# **SADDLE CLUB PRESERVATION PROPERTY DRAFT SITE USE PLAN**

***Transportation Corridor Agencies™***

**September 2019**

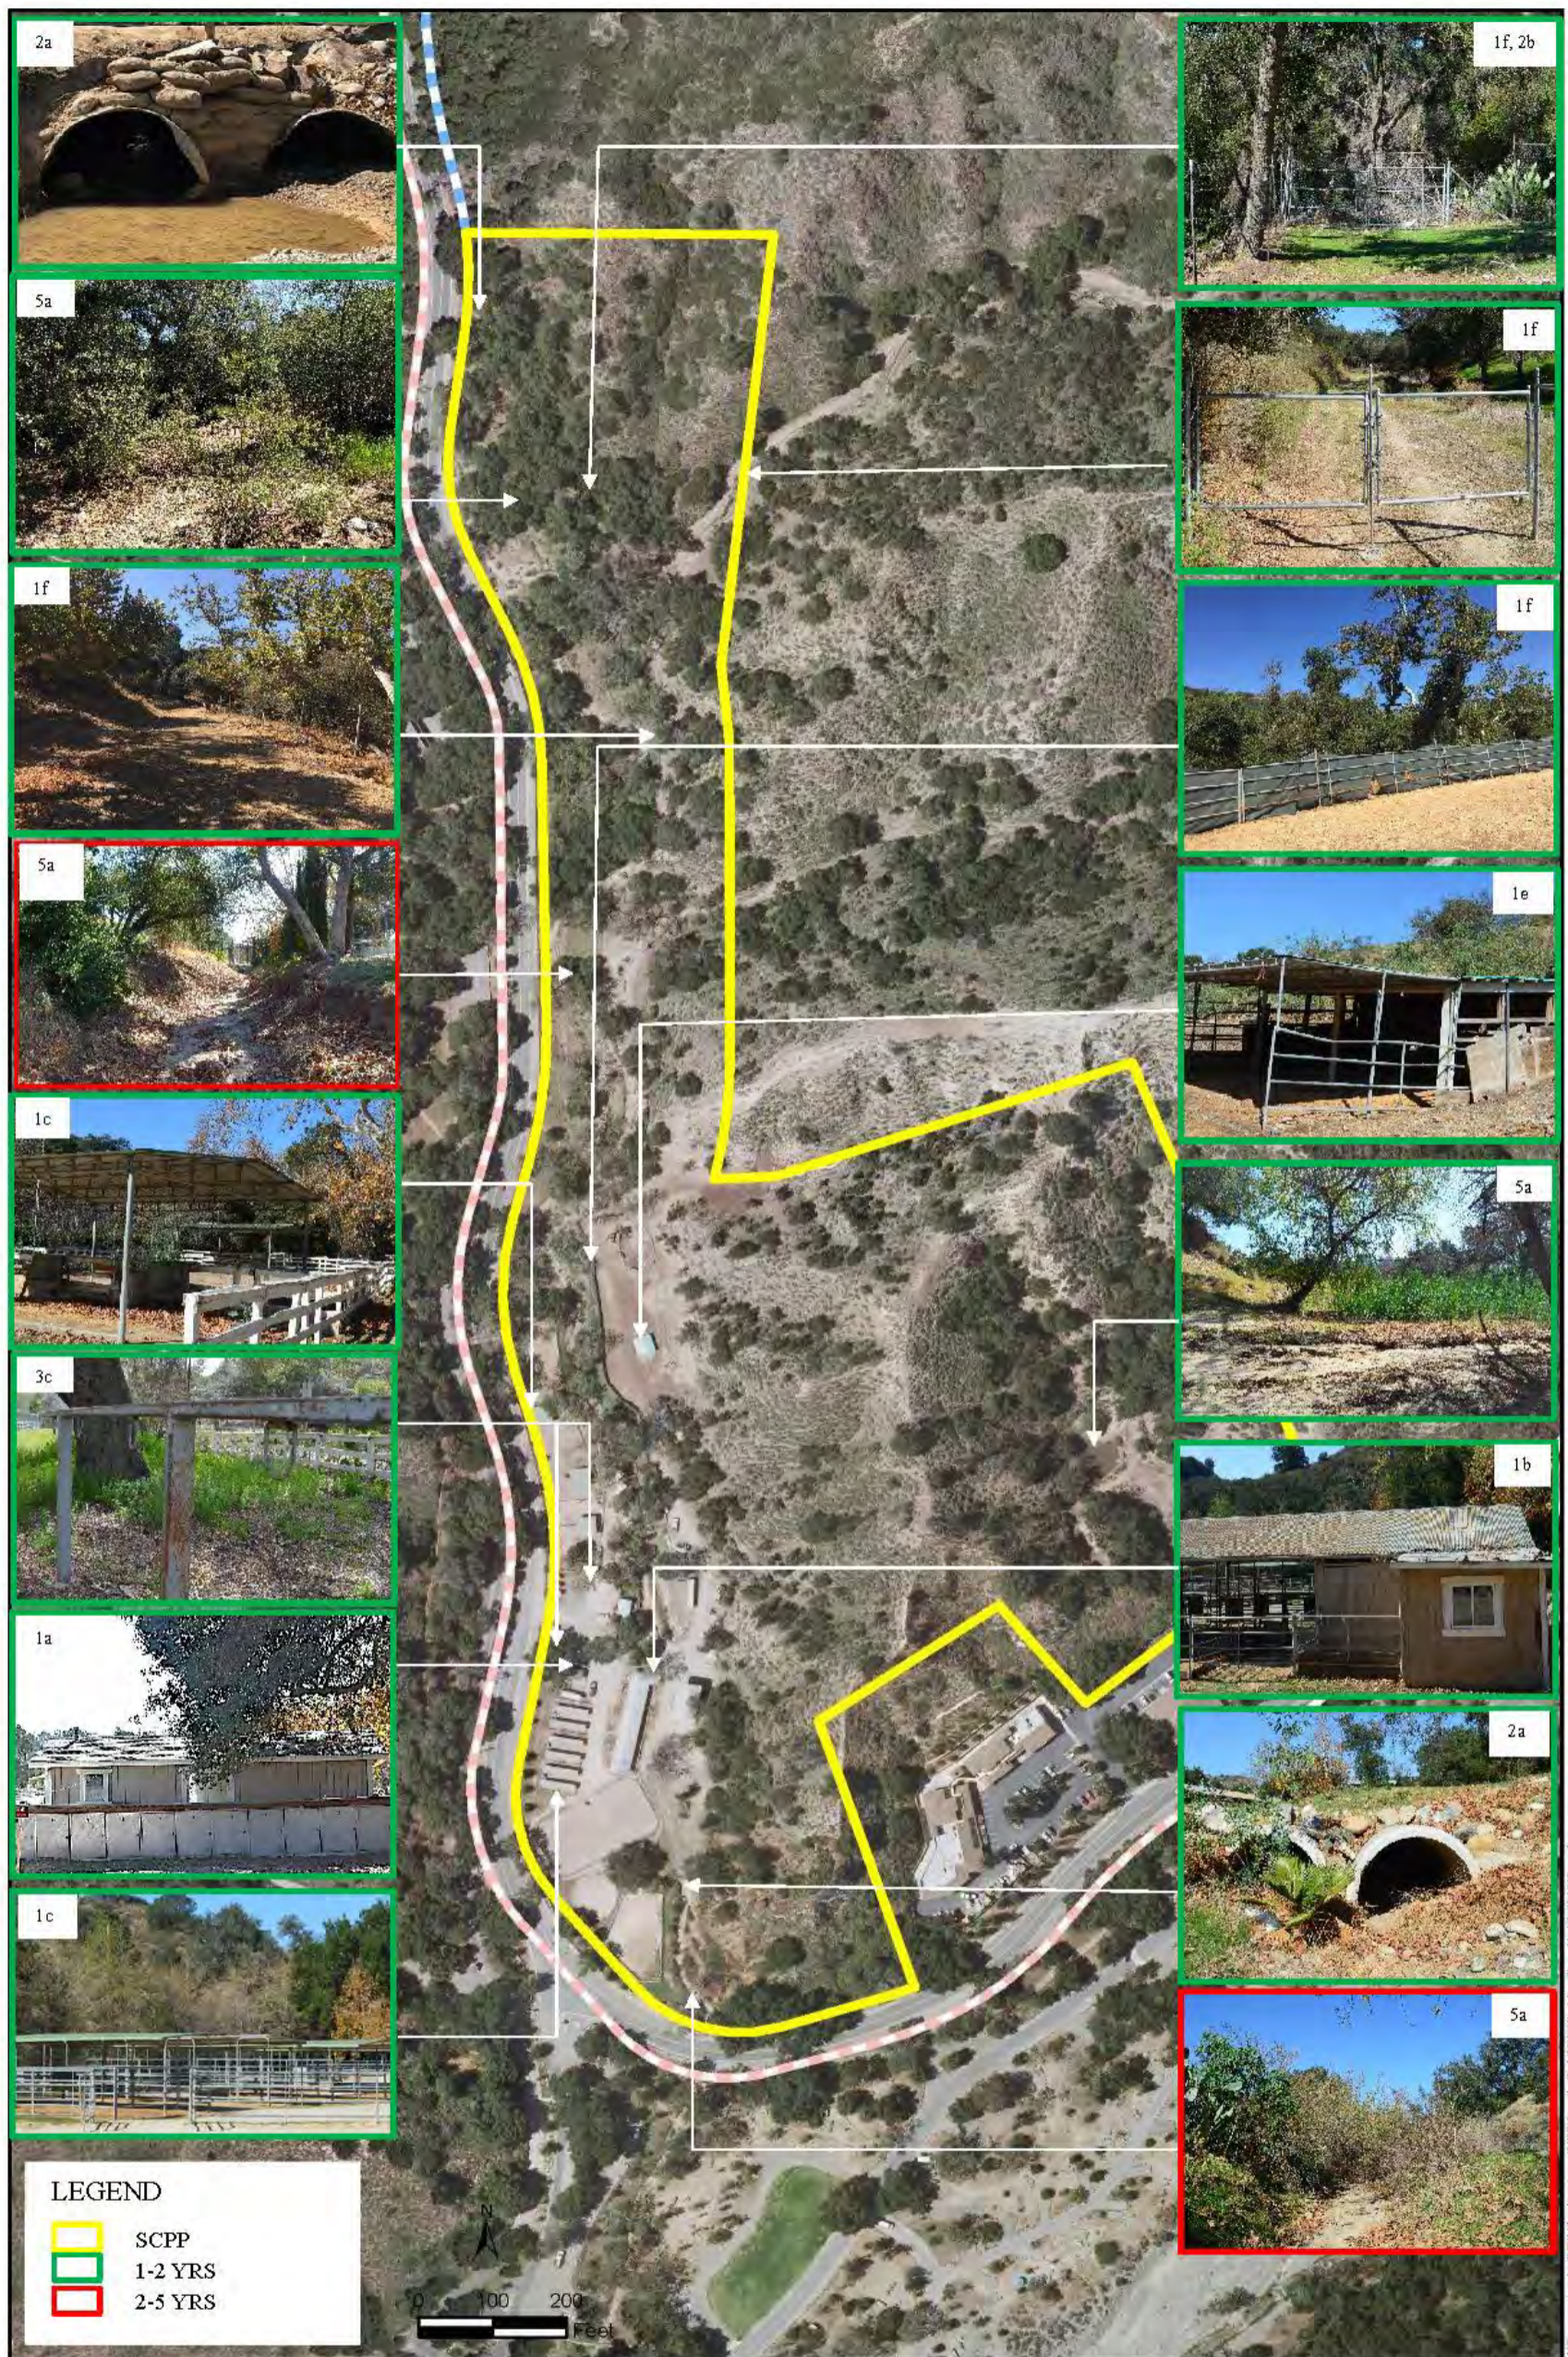
Figure 1: Activities Implementation Plan

\*Photo Number Corresponds to the Activity Number in Table 1

<sup>4</sup> Activity Number corresponds with the Photo Number in *Figure 1: Activities Implementation Plan*

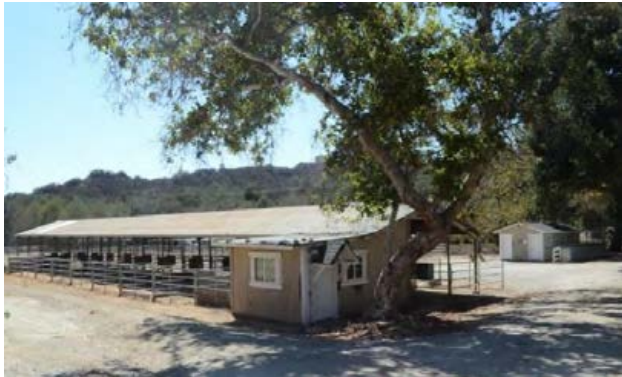
Demolish office and caretaker buildings, storage rooms, cap or remove septic tank(s)

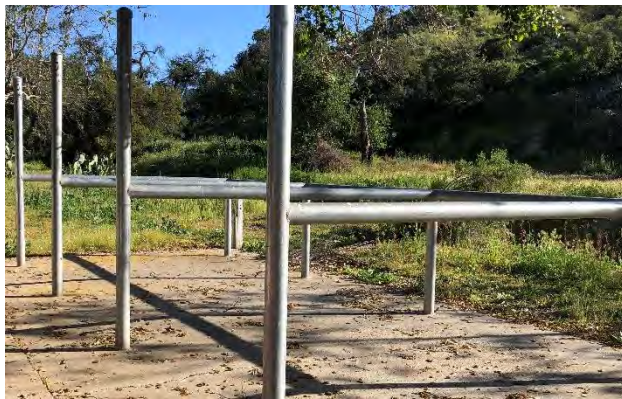
Demolish horse wash-out areas and other miscellaneous improvements onsite

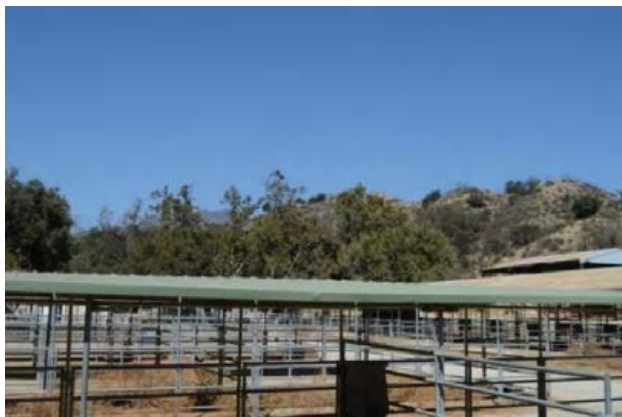
Demolish stables and cap all water supply pipes

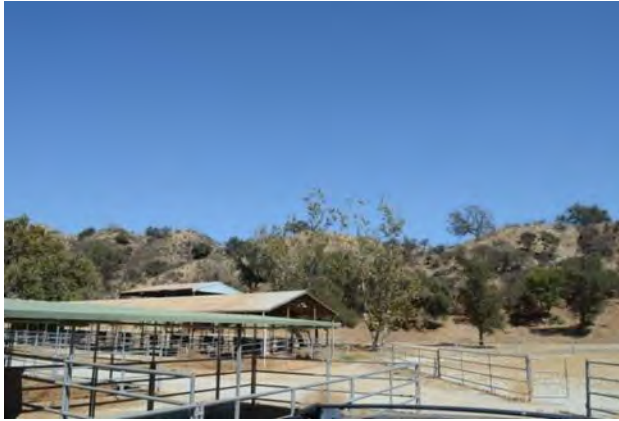
Demolish stables but leave in-place one coral for use by equestrian trail users to rest their horses. The remaining two corrals could potentially be used in cases of emergency to house horses in the area. Staff considered but did not carry forward the idea of using this site as an animal shelter during emergency evacuation episodes. OCFA<sup>12</sup> advised staff of potential challenges to using this property as an emergency evacuation center, including but not limited to the following:

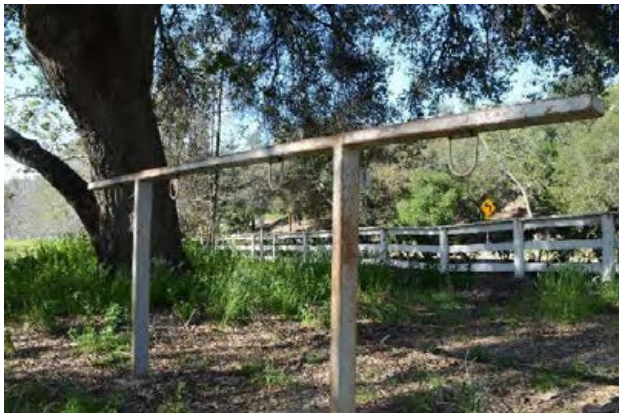
Demolish miscellaneous picket, barb-wire and chain-link fences; Retain and restore two horse tie-bars in the parking lot.

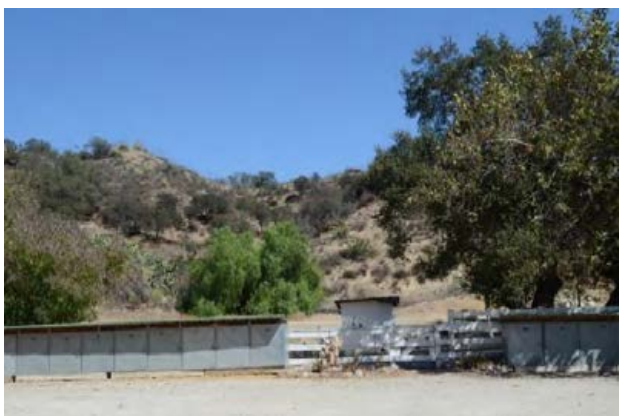
Remove all lockers and miscellaneous structures

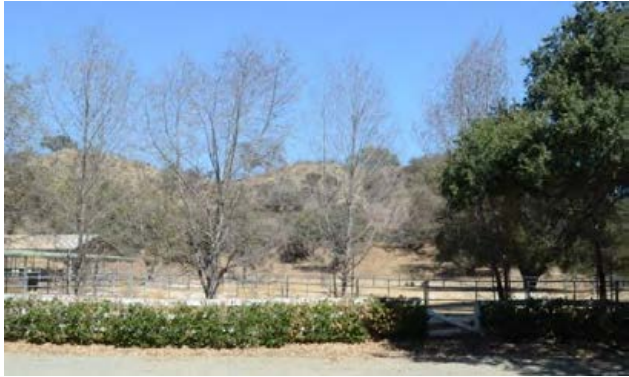
Remove targeted ornamental vegetation (e.g. Texas privet hedge)
